## Geoweb Lake Edge Treatment

*Lake at  
Westport Plaza  
St. Louis, MO*

# Geoweb Solution: Stabilize the Eroding Edge of the Lake

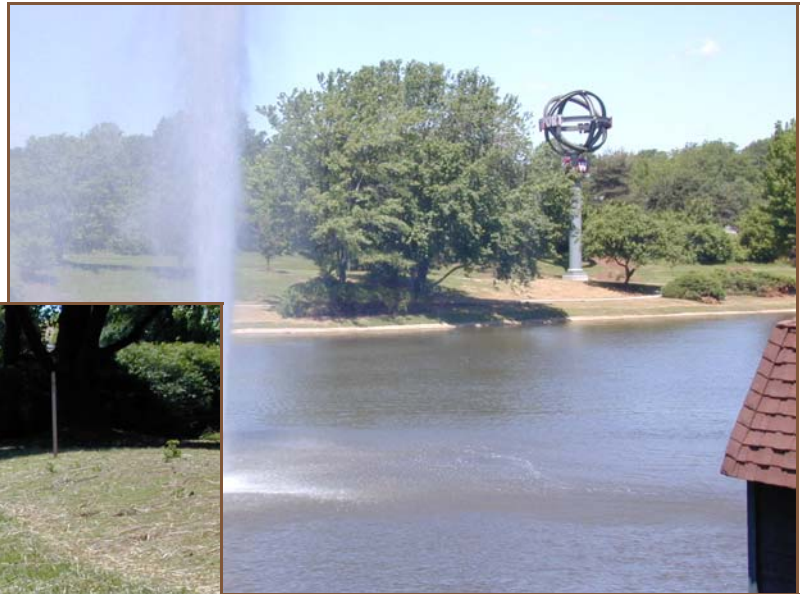
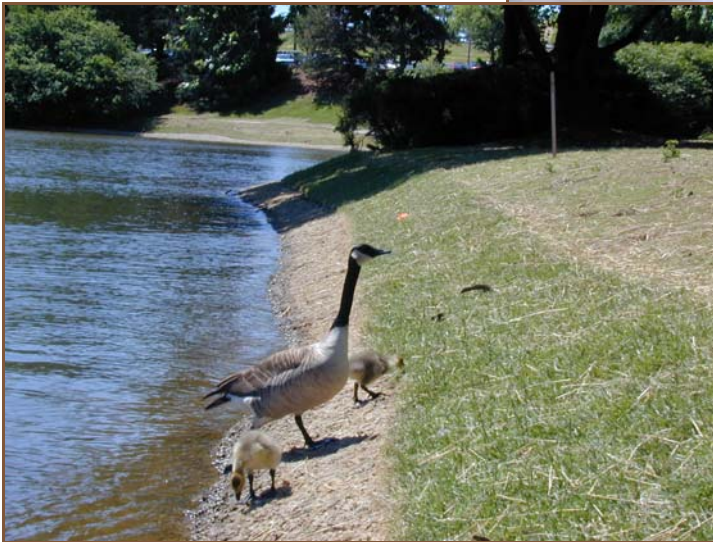
Installation is easy and fast. Concrete is placed in the bottom 5' of the Geoweb and soil with sod is placed in the top 3'. This provides 1' of concrete filled Geoweb above the water's surface.

Geoweb is used at this lake in Westport Plaza to provide erosion protection around the edge of the lake. Many people, and geese, like to walk down to the water's edge. Before the Geoweb installation, 2 attempts had been unsuccessful at providing a stable edge treatment to the lake. The Geoweb is the long term erosion solution to this project.

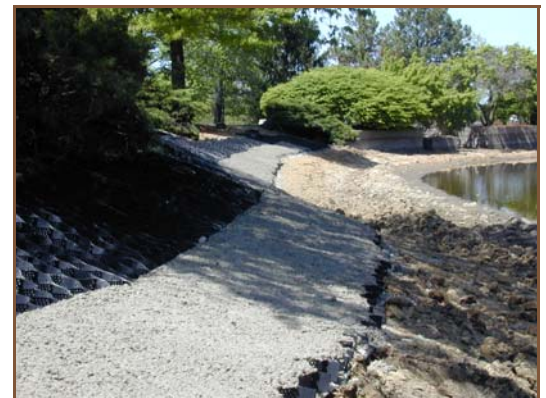
The concrete filled Geoweb provides a clean and continuous edge to the lake shoreline.
